2016 Field Survey
West Branch of Fish Creek
(From Kasoag Lake Outlet)

SLELO-PRISM Early Detection Surveillance
June 20th - 23rd, 28th - 29th, 2016

Report prepared by Ashley Gingeleski and Ben Hansknecht on July 5th, 2016

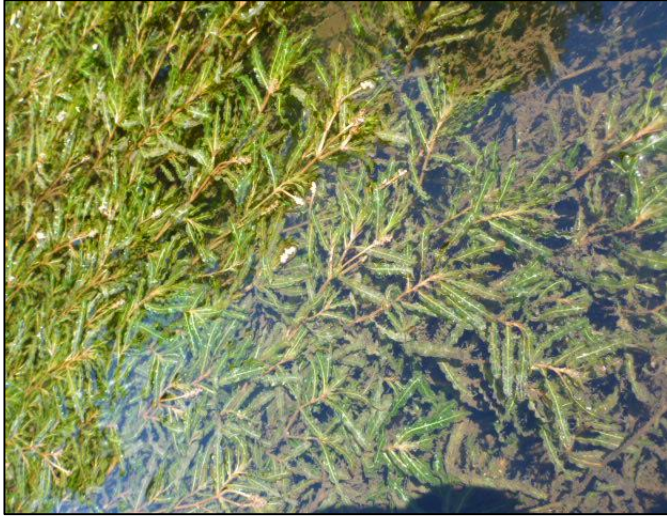
Figure 8. Curly-leaf pondweed at HPA 2.
Photo by Ashley Gingeleski.

Other species determined to be in Fish Creek during this survey include curly-leaf pondweed (**Figure 8**), Eurasian water-milfoil, phragmites, Japanese knotweed (**Figure 9**) and yellow iris.

Curly-leaf pondweed was found at HPAs 1 – 6 and 9 - 10, and the special focus area. Eurasian water-milfoil was found at HPAs 5, 9. Phragmites was found at HPA 9. Japanese Knotweed was found at HPA 8. Yellow iris was found at HPA 9. (Tables 1,2 and 3).
